**Flood Control Project Maintenance
Levee Inspections**
LMA District Cover Sheet
Spring 2020 Levee Inspection Results

Tehama County Flood Control and Water Conservation District

Waterway	Bank	Unit Miles
Unit No. 01 Deer Creek	Left	4.22

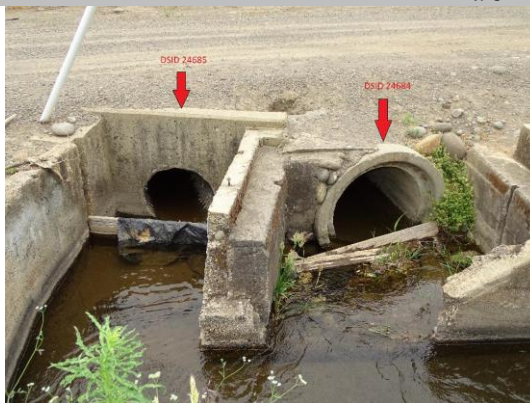
Photo 1 of 3 : UCIP_SP_2020_53998_79242.jpg

Comment Code						
Inspector Comment						
DS_ID:24684 FS_ID:53998 EP_NO: N/A Repair Type: Non-Urgent Crossing Status: Found UCIP Comments: 5/14/2019 Record remains Non-Urgent. No permit for this crossing was found. Pipe is designed to drain excess of water from irradiation canal to Deer Creek. Backflow prevention device is missing on this crossing. (O.Yakimov - DWR UCIP) 10/02/2013 No permit identified for this crossing. (W.Wylie - DWR UCIP) FIELD_STRUCT_DESC: 36-inch reinforced concrete drainage pipe through the levee, 0.5 feet below the crown. Concrete canal and distribution structure on the landside (LS) shoulder. FS Date: 5/14/2019 2:33:44 PM

Concrete headwall at irrigation canal on LS shoulder

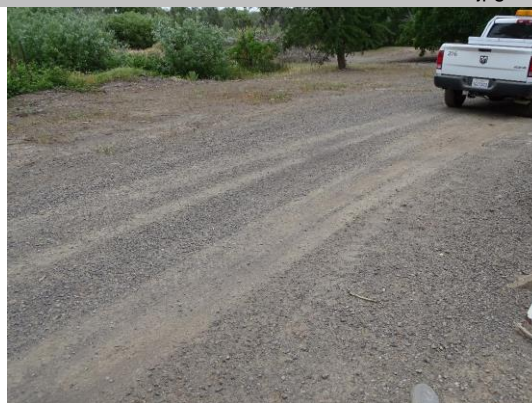
Photo 3 of 3 : UCIP_SP_2020_53998_79246.jpg

View of levee crown at the crossing

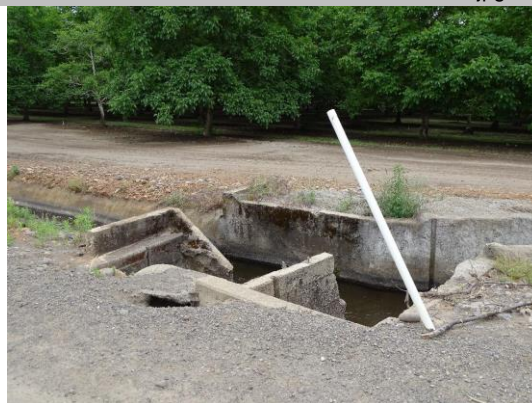
Photo 2 of 3 : UCIP_SP_2020_53999_79248.jpg

LM Start	0.17	Rating **	M	Issue No.	277
LM End	0.17	Issue Type +	En	Location *	
Category	Supplemental			GPS Latitude/Longitude	
				Start	End
Item	DWR UCIP Field Study			39.973285 °	39.973285 °
				-121.983531 °	-121.983531 °
DWR ID	24685				
Comment Code					
Inspector Comment					
DS_ID:24685 FS_ID:53999 EP_NO: N/A Repair Type: Non-Urgent Crossing Status: Found UCIP Comments: 05/14/2019 Pipe is designed to drain excess of water from irrigation canal to Deer Creek. (O.Yakimov - DWR UCIP)No permit identified for this crossing. FIELD_STRUCT_DESC: 24-inch reinforced concrete irrigation pipe through the levee, 2 feet below the crown. Concrete canal and distribution structure on the landside (LS) shoulder. Concrete U-shaped headwall and flap gate on the waterside (WS) toe. FS Date: 5/14/2019 3:06:17 PM

Irrigation canal at LS shoulder

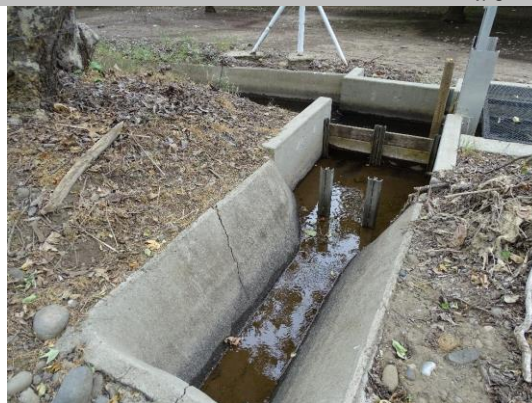
Photo 1 of 3 : UCIP_SP_2020_54000_79253.jpg

LM Start	0.49	Rating **	M	Issue No.	280
LM End	0.49	Issue Type +	En	Location *	
Category	Supplemental			GPS Latitude/Longitude	
				Start	End
Item	DWR UCIP Field Study			39.972280 °	39.972280 °
				-121.989227 °	-121.989227 °
DWR ID	24686				
Comment Code					
Inspector Comment					
DS_ID:24686 FS_ID:54000 EP_NO: N/A Repair Type: Non-Urgent Crossing Status: Found UCIP Comments: 05/14/2019 Pipe is designed to drain excess of water from irrigation canal to Deer Creek. Backflow prevention device is absent on this crossing. (O.Yakimov - DWR UCIP)No permit identified for crossing. FIELD_STRUCT_DESC: 20-inch reinforced concrete irrigation pipe through the levee, 2 feet below the crown. Concrete canal and distribution structure with slat boards on the landside (LS) shoulder. FS Date: 5/14/2019 3:11:32 PM

Concrete canal/distribution box on LS shoulder

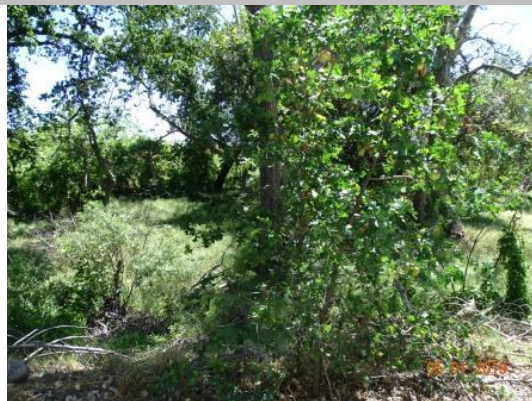
Photo 1 of 1 : SP_2020_NA0019_78_30_20200226_00007.jpg

View of a small tree on the landside toe. Spring 2019.

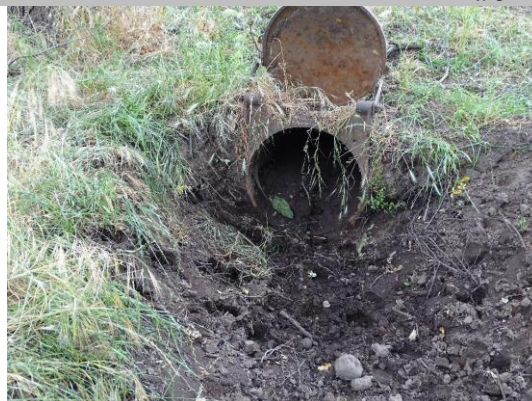
Photo 3 of 3 : UCIP_SP_2020_54006_79263.jpg

DS_ID:20770
FS_ID:54006
EP_NO: N/A
Repair Type: Non-Urgent
Crossing Status: Found
UCIP Comments: 05/14/2019 Pipe end on WS has been cleared from sediment buildup to let flap gate close properly, but the rest of pipe is still silted inside. Flap gate was fixed and operable now. (O.Yakimov - DWR UCIP)10/15/2018 Flap gate on WS end stuck open. Lower part of pipe is silted that makes impossible flap gate to fully close. Needs sediment cleanup around pipe outlet on WS. (O.Yakimov - DWR)12/05/2016 Sediment buildup inside pipe (see photo) and sediment buildup on WS blocking flap gate. Crossing has been downgraded from Urgent to Non-Urgent crossing was closed on both WS and LS. (O. Magana - DWR UCIP)10/02/2013 Flapgate blocked by soil buildup. (W. Wylie - DWR UCIP)
FIELD_STRUCT_DESC: 24-inch steel drainage pipe through the levee, 1.5 feet below the crown. Flap gate on the waterside (WS) toe.
[Additional Reference(s): DWR Levee Log, 1992. USACE Sacramento O&M Manual Unit 509, March 1957, As-built drawings available 50-4-2394 (Station 185+40)].

Sediment was cleared around flap gate

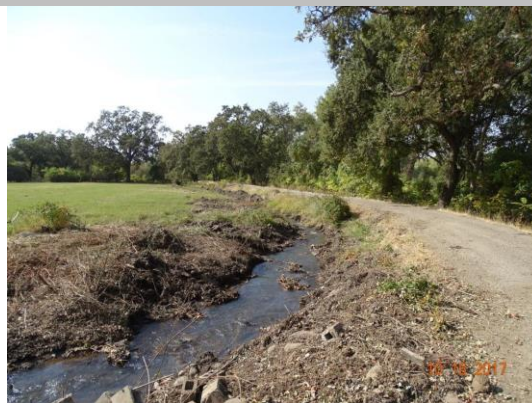
Photo 1 of 2 : SP_2020_NA0019_78_2_20200226_00001.jpg

LM Start	1.79	Rating **	U	Issue No.	2
LM End	2.22	Issue Type +	En	Location *	LS
Category	Earthen Levee			GPS Latitude/Longitude	
				Start	End
Item	Encroachments			39.969443 °	39.966921 °
				-122.012261 °	-122.019469 °
DWR ID	DWR_NA0019_01_s_2012_2				
Comment Code					
DT : Ditch					
Inspector Comment					
Repair the cleaned out irrigation ditch along the landside toe.

View of the irrigation ditch along the landside toe.

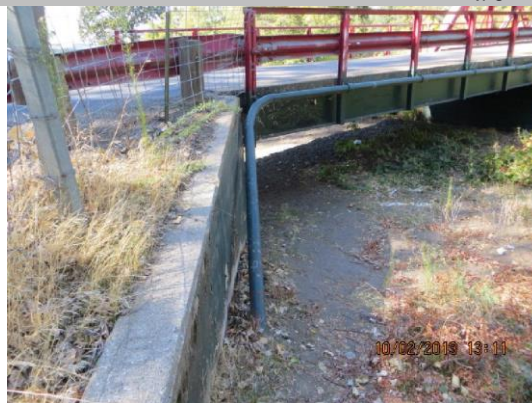
Photo 1 of 3 : UCIP_SP_2020_54007_39065.jpg

LM Start	1.88	Rating **	M	Issue No.	285	
LM End	1.88	Issue Type +	En	Location *		
Category	Supplemental			GPS Latitude/Longitude		
				Start	End	
Item	DWR UCIP Field Study			39.969156 °	39.969156 °	
				-122.013809 °	-122.013809 °	
DWR ID	24690					
Comment Code						
Inspector Comment						
DS_ID:24690 FS_ID:54007 EP_NO: N/A Repair Type: Non-Urgent Crossing Status: Found UCIP Comments: 05/14/2019 No changes to the crossing. (O.Yakimov - DWR UCIP)No permit identified for this crossing. FIELD_STRUCT_DESC: 4-inch steel communications conduit through the levee, at an unknown depth. Junction box off the landside (LS) toe next to JP and roadway. Conduit visible on upstream side of bridge at Deer Creek crossing. FS Date: 5/14/2019 3:54:01 PM

Conduit visible at upstream side of bridge

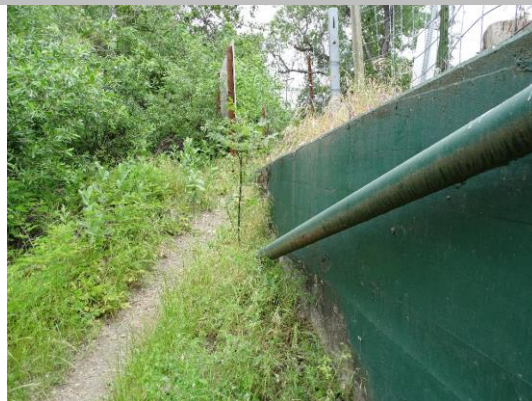
Photo 3 of 3 : UCIP_SP_2020_54007_79266.jpg

Underground conduit goes toward the levee

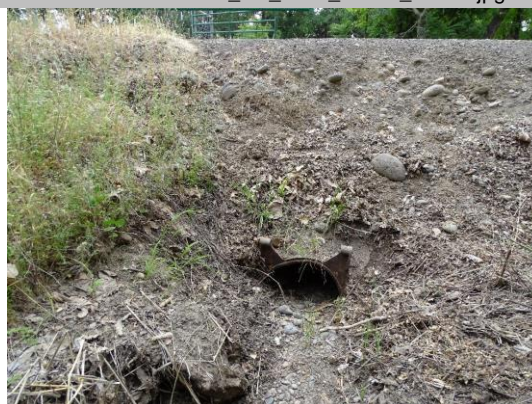
Photo 2 of 3 : UCIP_SP_2020_54008_79271.jpg

DS_ID:20769
FS_ID:54008
EP_NO: N/A
Repair Type: Urgent
Crossing Status: Found
UCIP Comments: 05/14/20198 Same as last inspection. Flapgate on WS is missing, pipe partially blocked with sedimen. (O.Yakimov - DWR UCIP)10/15/2018 Flapgate on WS is missing, pipe partially blocked with sediment. (O.Yakimov - DWR)12/05/2016 same as last inspection. Crossing remains "Urgent" WS opened during flood season due to damaged flap gate. (O. Magana - DWR UCIP)10/02/2013 Flapgate missing or burried on WS toe. Pipe partially blocked by soil on WS toe. (W. Wylie - DWR UCIP)
FIELD_STRUCT_DESC: 24-inch corrugated metal drainage pipe through the levee, 7 feet below the crown. Flap gate located on the waterside (WS) end. A 5-foot by 5-foot concrete control structure located on the landside (LS) toe. [Additional Reference(s): DWR Levee Log, 1992. USACE Sacramento O&M Manual Unit 509, March 1957, As-built drawing no. 50-4-2394 (Station 176+10)].

Partially silted pipe at WS toe missing flap gate

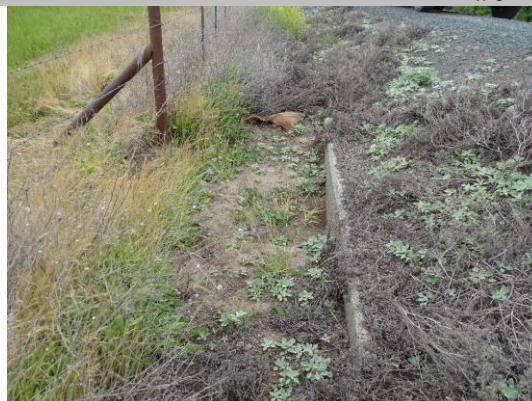
Photo 1 of 3 : UCIP_SP_2020_54011_79272.jpg

Comment Code						
Inspector Comment						
DS_ID:20877 FS_ID:54011 EP_NO: N/A Repair Type: Non-Urgent Crossing Status: Found UCIP Comments: 05/14/2019 Pipe outlet and headwall were excavated to evaluate pipe condition. Pipe is completely filled with soil that makes impossible to clear it for DMP internal video inspection. Pipe may be rehabilitated under DMP Phase II or removed. Excavated soil was backfilled. (O.Yakimov - DWR UCIP)Headwall covered with soil. Needs to be cleared at both ends. FIELD_STRUCT_DESC: 24-inch corrugated metal pipe through the levee 5-feet below the crown. Calco automatic drainage gate. Originally included in O+M manual (1957). As-built drawings available 50-4-2394. FS Date: 5/14/2019 8:37:31 AM

Concrete headwall on LS toe

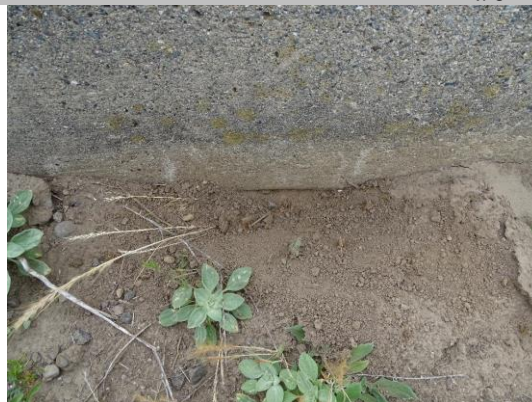
Photo 2 of 3 : UCIP_SP_2020_54011_79273.jpg

Concrete headwall on LS toe: top of pipe visible

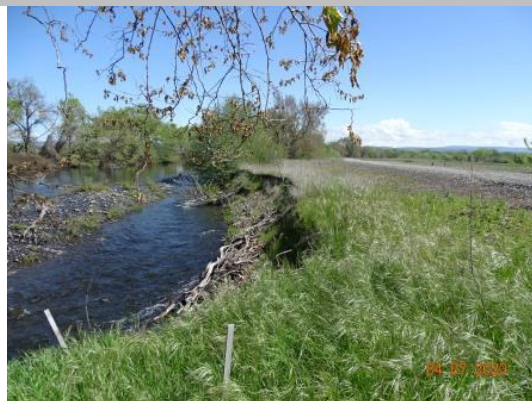
Photo 1 of 1 : SP_2020_NA0019_78_43_20200416_00073.jpg

LM Start	2.76	Rating **	M	Issue No.	43
LM End	2.78	Issue Type +	Ma	Location *	WS
Category	Earthen Levee			GPS Latitude/Longitude	
				Start	End
Item	Erosion / Bank Caving			39.964990 °	39.964763 °
				-122.028740 °	-122.029082 °
DWR ID	DWR_NA0019_01_s_2017_43				
Comment Code					
E2 : Schedule repair of erosion site prior to the next inspection.					
Inspector Comment					
Significant erosion at the waterside toe.					
Site ID No:271					
Site Designation:LMA-72

View of erosion along the waterside toe. Spring 2020.

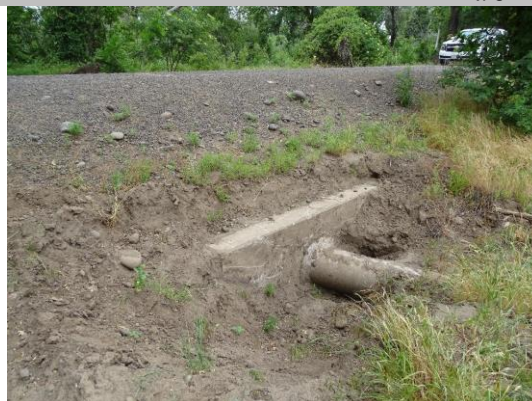
Photo 1 of 3 : UCIP_SP_2020_54012_79276.jpg

Comment Code						
Inspector Comment						
DS_ID:20767 FS_ID:54012 EP_NO: N/A Repair Type: Non-Urgent Crossing Status: Found UCIP Comments: 05/14/2019 Pipe outlet and headwall were excavated to evaluate pipe condition. Discovered a concrete pipe that connects nearby ditch with inlet of this crossing to drain water from the ditch. Cleared pipe outlet at WS toe. (O.Yakimov - DWR UCIP) Pipe blocked by soil. FIELD_STRUCT_DESC: 24-inch corrugated metal drainage pipe through the levee, 6 feet below the crown. Flap gate on the waterside (WS) end. [Additional Reference(s): DWR Levee Log, 1992. USACE Sacramento O&M Manual 509, March 1957, (Assumed Station 137+50) Drawing No. 50-4-2394]. FS Date: 5/14/2019 9:02:19 AM

Headwal and concrete pipe at LS toe

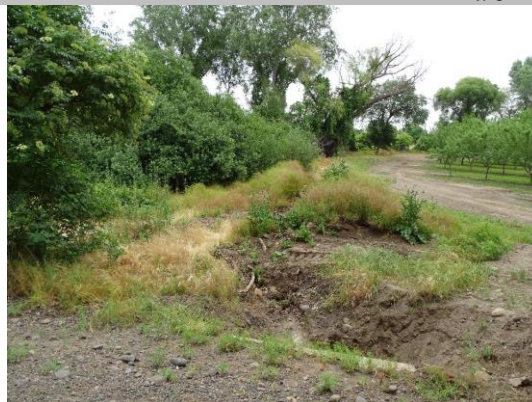
Photo 2 of 3 : UCIP_SP_2020_54012_79277.jpg

View of landside with headwall at the toe

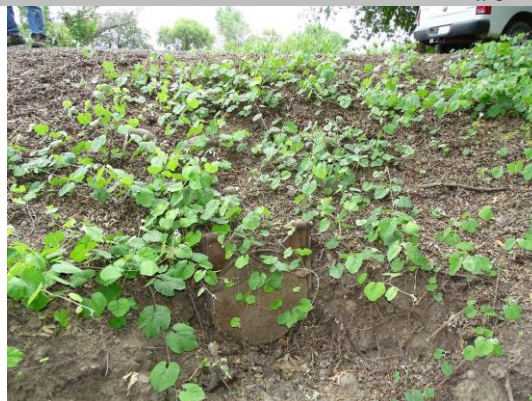
Photo 3 of 3 : UCIP_SP_2020_54012_79278.jpg

Pipe outlet with flap gate at WS toe

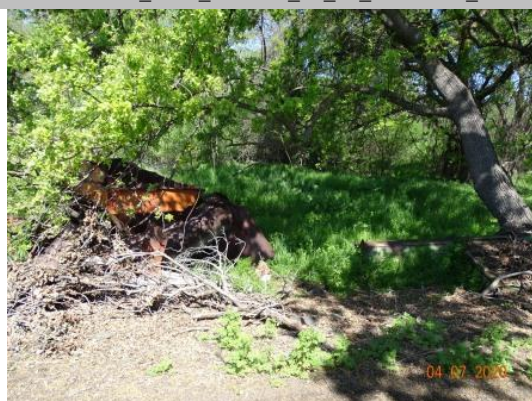
Photo 1 of 1 : SP_2020_NA0019_78_37_20200413_00068.jpg

View of the scrap equipment along the waterside toe. Spring 2020.

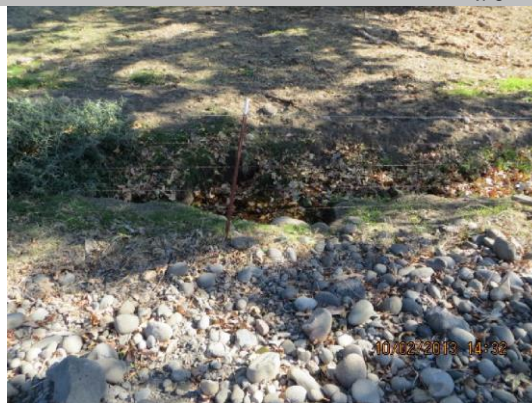
Photo 1 of 3 : UCIP_SP_2020_54013_38952.jpg

LM Start	3.29	Rating **	M	Issue No.	291	
LM End	3.29	Issue Type +	En	Location *		
Category	Supplemental			GPS Latitude/Longitude		
				Start		End
Item	DWR UCIP Field Study			39.947484 °	39.947484 °	
				-122.049011 °	-122.049011 °	
DWR ID	20766					
Comment Code						
Inspector Comment						
DS_ID:20766 FS_ID:54013 EP_NO: N/A Repair Type: Non-Urgent Crossing Status: Not Found UCIP Comments: 05/14/2019 Unable to locate low spot. Crossing not found. Crossing status updated to Not Found and suggested to include this crossing to geophysical survey to determine accurate location. (O.Yakimov - DWR UCIP)Pipe buried. Water flows to low spot and dissappears, but pipe not visible. FIELD_STRUCT_DESC: 24-inch pipe through the levee 8-feet below the crown, flap gate on waterward end. Originally included in O+M manual (1957). As-built drawing No. 50-4-2394. FS Date: 5/14/2019 9:35:22 AM

Low spot with water on LS toe.

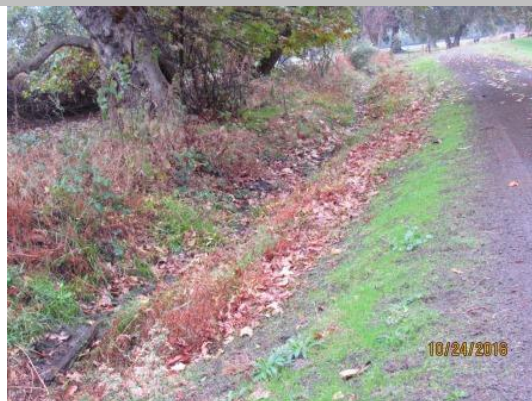
Photo 1 of 1 : SP_2020_NA0019_78_35_20200226_00008.jpg

View of the vegetation along the landside slope and toe.

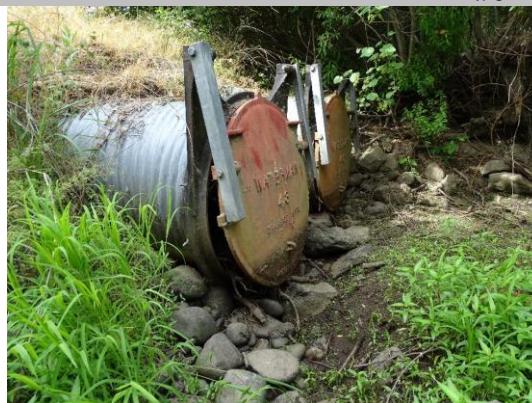
Photo 1 of 3 : UCIP_SP_2020_54016_79282.jpg

LM Start	3.59	Rating **	M	Issue No.	294	
LM End	3.59	Issue Type +	En	Location *		
Category	Supplemental			GPS Latitude/Longitude		
				Start	End	
Item	DWR UCIP Field Study			39.945964 °	39.945964 °	
				-122.054229 °	-122.054229 °	
DWR ID	24687					
Comment Code						
Inspector Comment						
DS_ID:24687						
FS_ID:54016						
EP_NO: N/A						
Repair Type: Non-Urgent						
Crossing Status: Found						
UCIP Comments: 05/14/2019 Debris inside of pipe outlet on WS should be cleared for proper flap gate operation. (O.Yakimov - DWR UCIP)No permit identified for this crossing.						
FIELD_STRUCT_DESC: 48-inch corrugated metal drainage pipe through the levee, 6 feet below the crown. Flap gate on the waterside (WS) end.						
FS Date: 5/14/2019 10:08:10 AM

Vlew of pipe outlet on WS

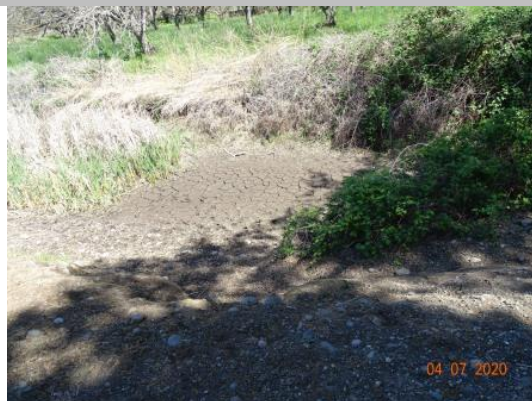
Photo 1 of 1 : SP_2020_NA0019_78_15_20200413_00071.jpg

View of slope erosion caused by livestock along the landside slope.
Spring 2020.

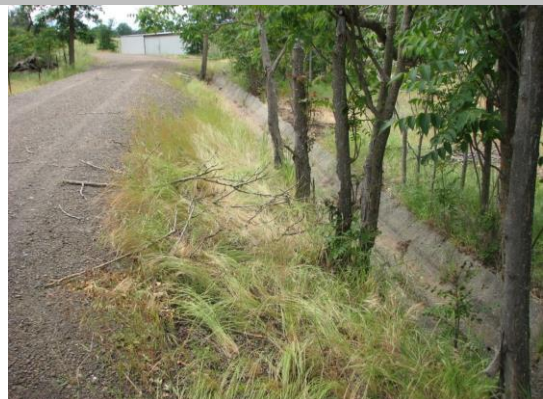
Photo 1 of 1 : SP_2020_NA0019_79_11_20200226_00004.jpg

View of a concrete-lined ditch along the levee toe.

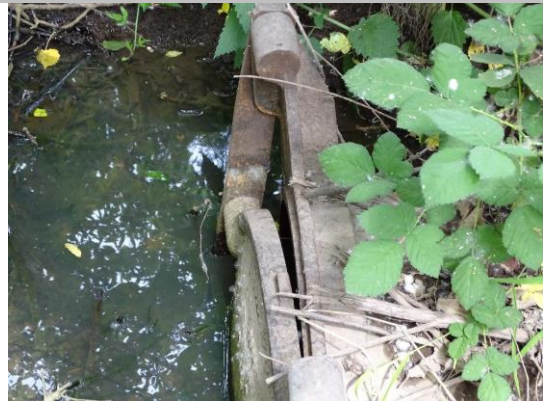
Photo 3 of 3 : UCIP_SP_2020_53997_79238.jpg

Flapgate gap due to sediment buildup at the bottom of pipe

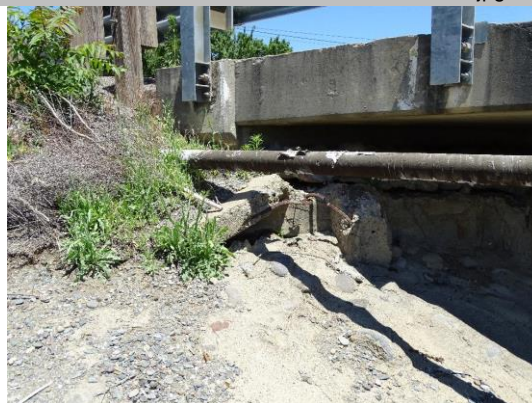
Photo 2 of 3 : UCIP_SP_2020_54137_79678.jpg

Pipe daylights on WS shoulder

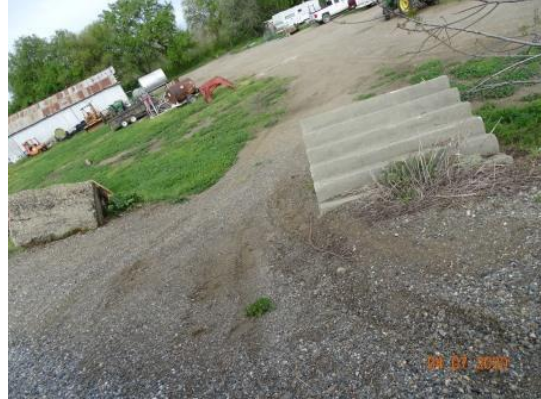
Photo 1 of 1 : SP_2020_NA0019_81_25_20200413_00087.jpg

View of the damaged landside slope caused by vehicle traffic. Spring 2020.

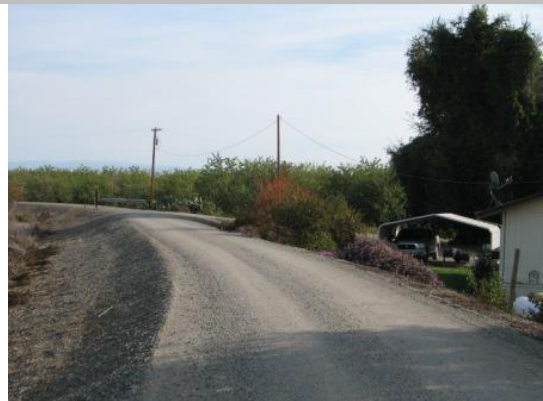
Photo 1 of 1 : SP_2020_NA0019_82_2_20200226_00001.jpg

View of the landscaping along the slope.
